NATIONAL PHOTOGRAPHIC INTERPRETATION CENTER

basic imagery interpretation report

Activity at Severodvinsk Shipyard Complex 1 January (S)

25X1 RCA-09/0027/8(25X1 SEPTEMBER 1980 Copy 49

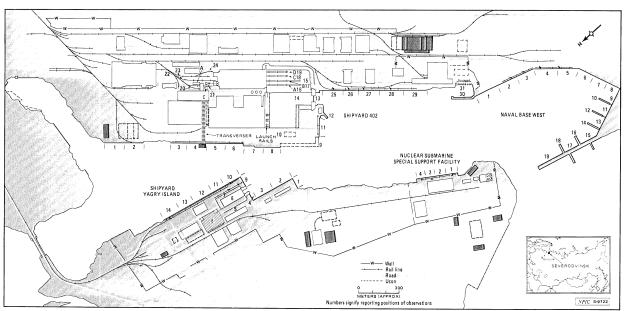
FIGURE 1. LAYOUT OF SEVERODVINSK COMPLEX, USSR

BASIC DESCRIPTION				
4. (S) The Severodvinsk Shipyard Complex (Figure 1) comprises four installations—Shipyard 402, Shipyard Yagry Island, the Nuclear Submarine Special Support Facility (NSSSF), and Naval Base West. Reporting positions (RPs) used throughout this report and the submarine movements are shown in Table 1 and keyed to Figure 1.	when snow and ice had again been cleared from rail D. However, on the flotation device supports had been moved directly onto rails C and D (Figure 2), and on snow and ice were being cleared along each side of launch rail D. By the flotation device supports had been realigned along rail D and the area again appeared to be ready for the roll-out	25X1 25X1 25X1 25X1 25X1		
Shipyard 402	of a submarine. On a probable railroad track cleaner was in operation (Figure 3) on the rails and the roll-out of a submarine was again	25 X 1

5. (S/D) For ease of reporting, discussion, and visual aids, the launch rails in front of construction hall 3 are designated launch rails 1, 2, and 3, with rail 1 being the northernmost rail (Figure 1).	thought to be imminent. However, on the barge with the flotation devices (required for the launch of a submarine) had been moved to the east quay, suggesting that the roll-out/launch of D-III SSBN unit 12 might be further delayed. By	25X1		
D-Series Activity	cables had been strung-out from the winch house to the doors of construction hall 1, indicating that the roll out of D. III SSPN unit 12	25 X 1
